REQUEST FOR COUNCIL ACTION CITY OF SAN DIEGO				CERTIFICATE NUMBER (FOR COMPTROLLER'S USE ONLY)	
TO: CITY COUNCIL		FROM (ORIGINATING DEPARTMENT): Transportation&Storm Water Dept		DATE: 9/17/2015	
SUBJECT: Winter Storm Preparation, Master Maintenance Program Annual Report and Channel Prioritization					
PRIMARY CONTACT (NAME, PHONE): Gene Matter,(619) 527-7506; MS 44			SECONDARY CONTACT (NAME, PHONE): Drew Kleis, (858) 541-4320; MS 1900		
COMPLETE FOR ACCOUNTING PURPOSES					
FUND					
FUNCTIONAL AREA					
COST CENTER					
GENERAL LEDGER ACCT					
WBS OR INTERNAL ORDER					
CAPITAL PROJECT No.					
AMOUNT	0.00	0.00	0.00	0.00	0.00
FUND					
FUNCTIONAL AREA					
COST CENTER					
GENERAL LEDGER ACCT					
WBS OR INTERNAL ORDER					
CAPITAL PROJECT No.					
AMOUNT	0.00	0.00	0.00	0.00	0.00
COST SUMMARY (IF APPLICABLE): This is an informational item only					
ROUTING AND APPROVALS					
CONTRIBUTORS/REVIEWERS:		APPROVING AUTHORITY	APPROVAL SIGNATURE	DATE SIGNED

COUNCIL ACTION
EXECUTIVE SUMMARY SHEET
CITY OF SAN DIEGO

SUBJECT: Winter Storm Preparation, Master Maintenance Program Annual Report and Channel Prioritization

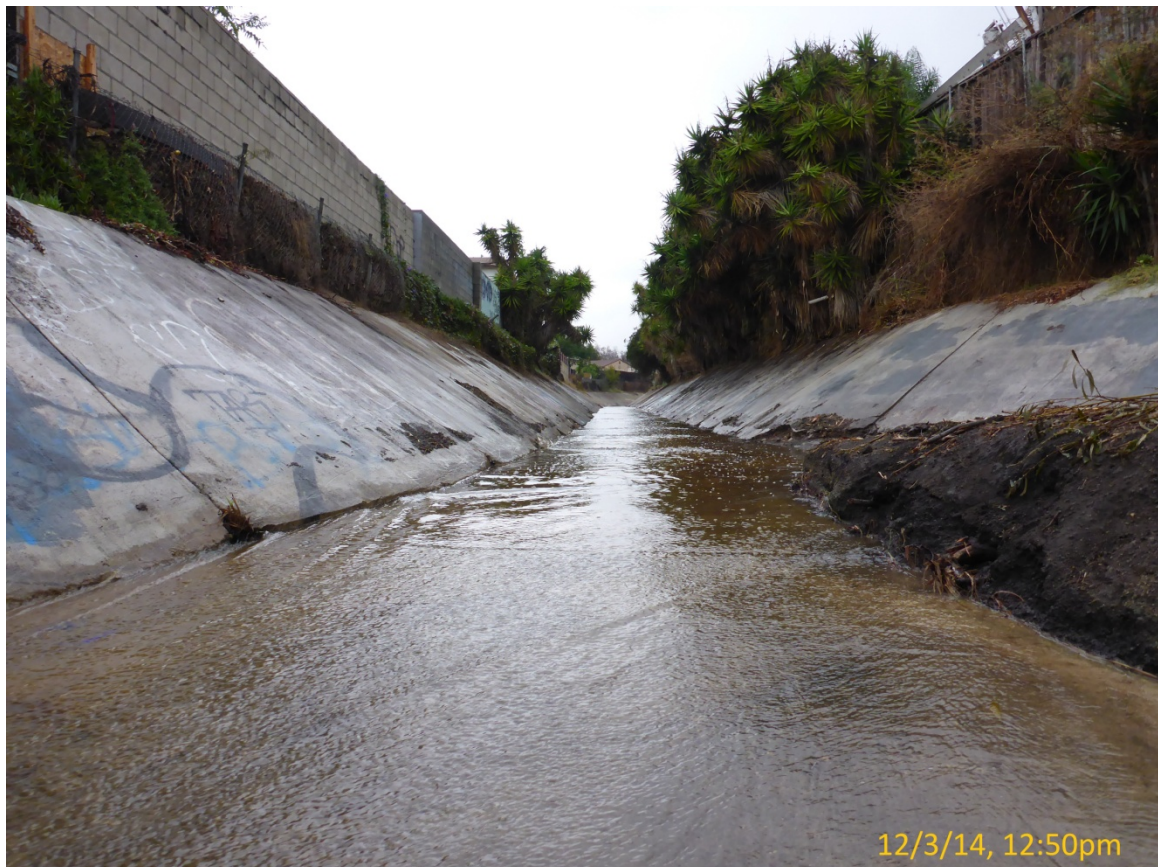
Photo 12: Smythe Channel Emergency Post-Maintenance 12/3/14

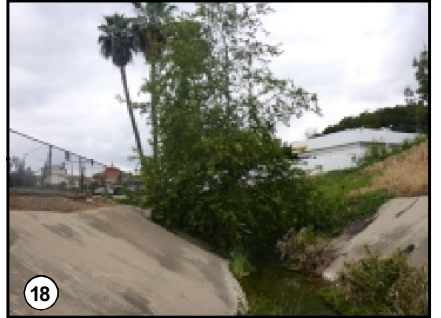
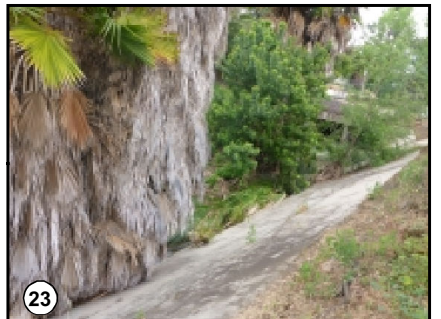
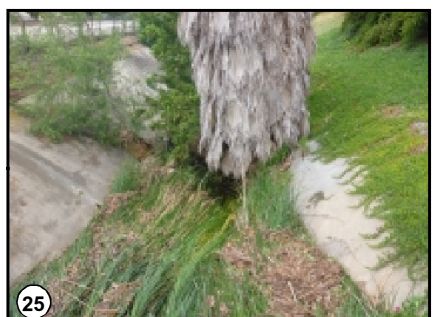
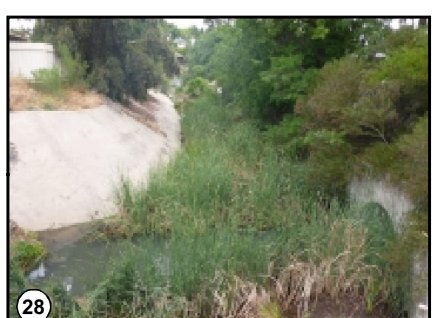
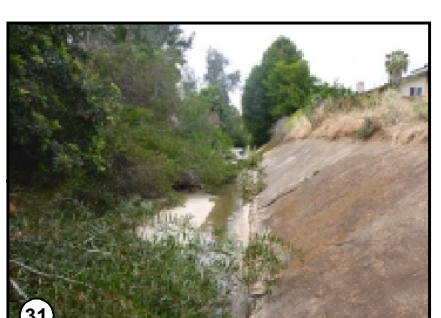
MMP Map # 03

- Channel Prioritization Score: 93.6 out of 100
 - Flood Hazard Score: 73.8 out of 75
 - Water Quality Score: 6 out of 10
 - Community Input Score: 10 out of 10
 - Aesthetics Score: 3.8 out of 5
- Capacity Prior to Maintenance: Less than 2-year storm event
- Capacity After Maintenance (As-built Capacity): 100-year storm event
- Clogging Potential: HIGH
- Approximate Vegetation Coverage: HIGH
- Surrounding Area: Residential
- Infrastructure Failures: Yes
- Site Evaluation Date: May 9, 2015
- Notes/Comments: *The channel has holes and cracks in the concrete throughout portions of the channel. It is recommended that these areas be maintained to prevent continuous vegetation growth to exacerbate these areas.*

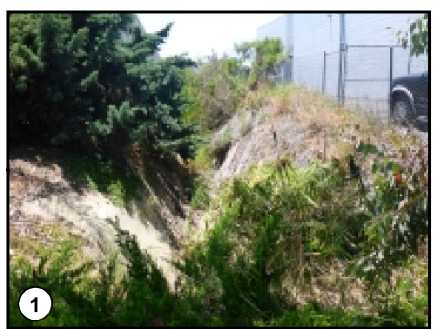
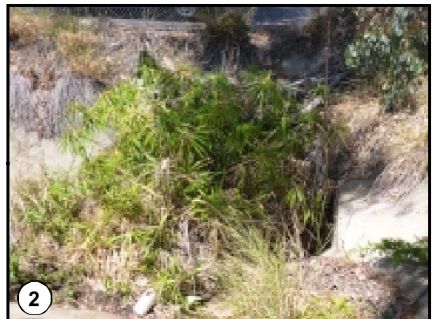
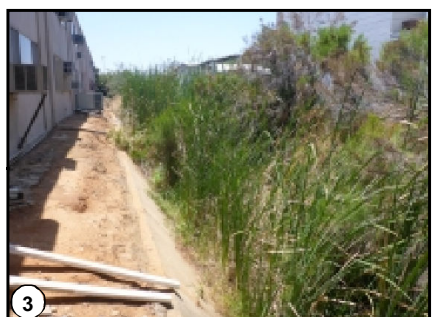
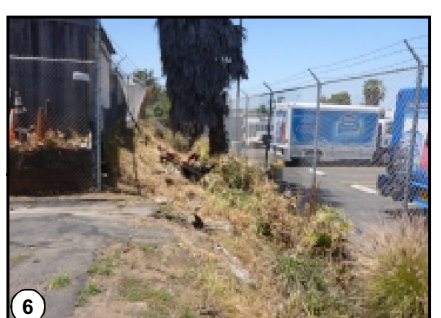
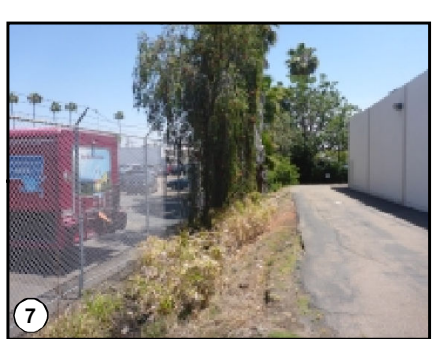
MMP Map # 37

- Channel Prioritization ScoreA
94.8 out of 100
 - Flood Hazard ScoreA
73.8 out of 75
 - Water Quality ScoreA
6 out of 10
 - Community Input ScoreA
10 out of 10
 - Besthetics ScoreA
5 out of 5
- Capacity Prior to MaintenanceA
Less than 2-year storm event
- Capacity Bfter Maintenance (B s-built Capacity) A
100-year storm event
- Clogging PotentialAHIGH
- B pproximate Vegetation CoverageAHIGH
- Surrounding B reaAIndustrial
- Infrastructure FailuresA
NONE
- Site Evaluation DateA
May 12, 2015
- Notes/CommentsA
There are trash and palm cuttings behind 7990 Daggest St. in Channel

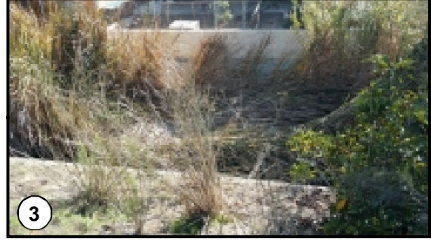
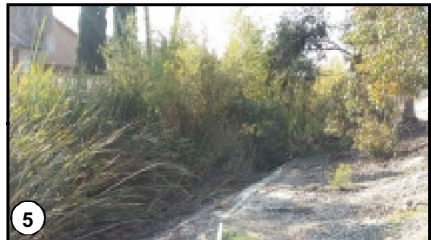
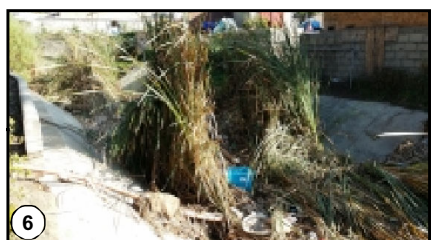
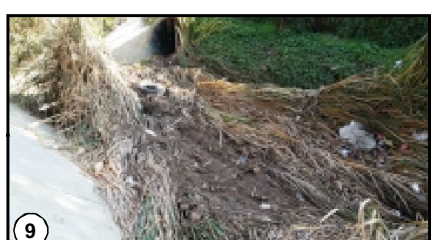
- **Channel Prioritization Score:**
94.0 out of 100
 - Flood Hazard Score:
75.0 out of 75
 - Water Quality Score:
5 out of 10
 - Community Input Score:
9 out of 10
 - Aesthetics Score:
5 out of 5
- **Capacity Prior to Maintenance:**
Less than 2-year storm event
- **Capacity After Maintenance (As-built Capacity):**
100-year storm event
- **Clogging Potential:** HIGH
- **Approximate Vegetation Coverage:** HIGH
- **Surrounding Area:** Residential
- **Infrastructure Failures:** None
- **Site Evaluation Date:** June 12, 2015
- **Notes/Comments:**
There is noticeable sediment and dense vegetation throughout channel reach. Since the channel has a concrete bottom a high risk of vegetation detaching from the channel bottom and flowing downstream, clogging the culvert exists.

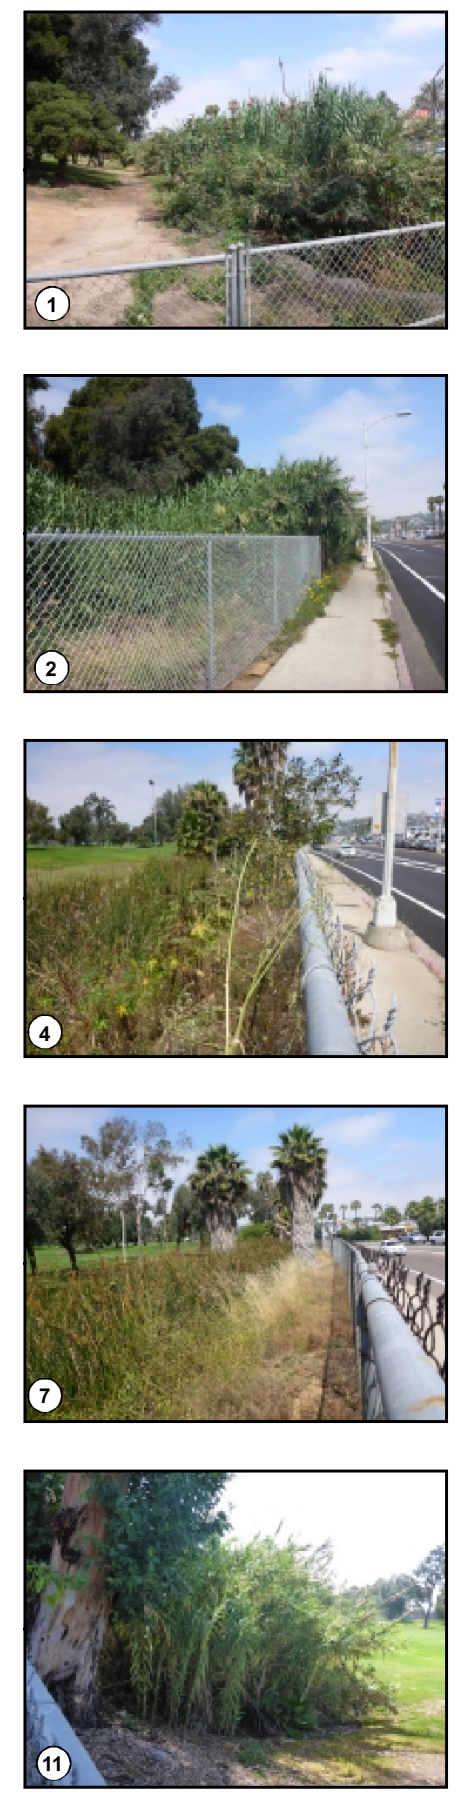
- Channel Prioritization Score: **56.1 out of 100**
 - Flood Hazard Score: **38.1 out of 75**
 - Water Quality Score: **6 out of 10**
 - Community Input Score: **7 out of 10**
 - Aesthetics Score: **5 out of 5**
- Capacity Prior to Maintenance: **5-year storm event**
- Capacity After Maintenance (As-built Capacity): **100-year storm event**
- Clogging Potential: **HIGH**
- Approximate Vegetation Coverage: **HIGH**
- Surrounding Area: **Commercial**
- Infrastructure Failures: **NONE**
- Site Evaluation Date: **May 29, 2015**
- Notes/Comments: **Based on site photos taken by the City of San Diego, heavy vegetation exists in the channel. A high risk of vegetation flowing downstream and clogging the culvert exists.**
