1244 OLIVER TENTATIVE MAP - PROJECT NO. 81316

**Building Condition Report
Analysis and Executive Summary
July 10, 2007
Version 1**

1244 Oliver
San Diego, Ca 92109

Client(s): Clarke
Inspection Date: 7/9/2007

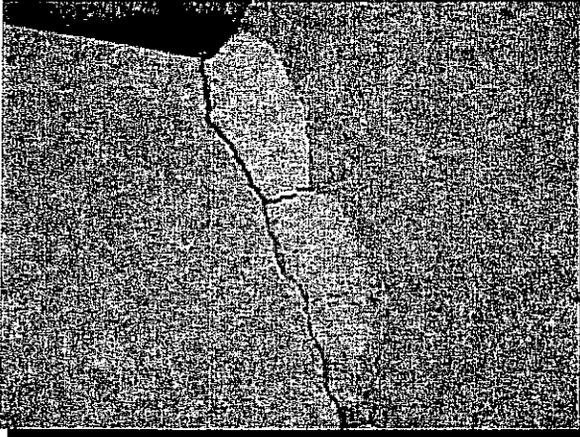
3.3 Picture 2

- (2) There are several cracks and vertical displacement greater than 3/4 of an inch in the walkways. This is a potential trip concern for persons using the walkways. As a safety upgrade, grinding down the affected areas is recommended.

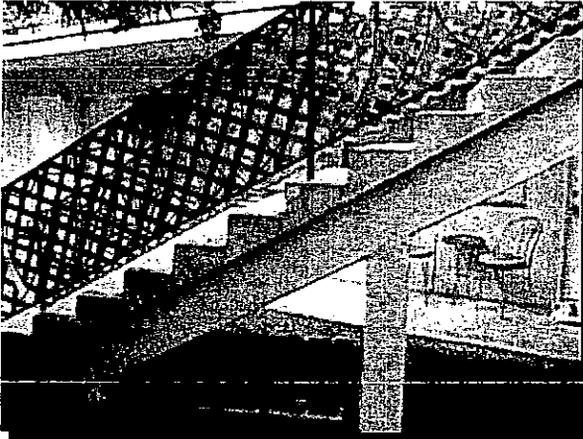
3.4 Picture 1

- (1) The exterior stair handrails at the right side (facing front) are damaged a baluster is corroded and broken free from the concrete step. All handrails or guardrails need proper attachment or securing to provide adequate support and safety. Have a qualified technician repair or replace the railing.

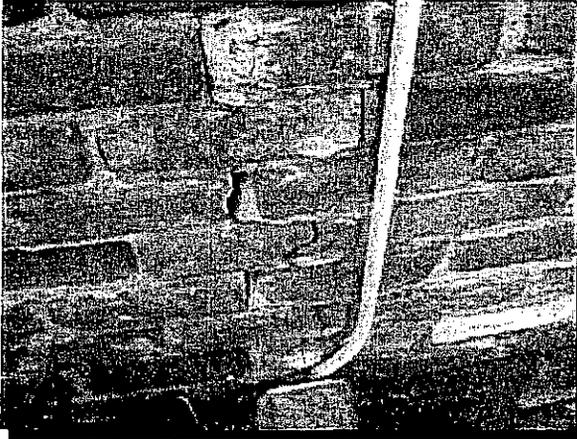
3.6 Picture 1

- Settlement cracking of south brick and mortar pony wall. Stabilize and repair crack.

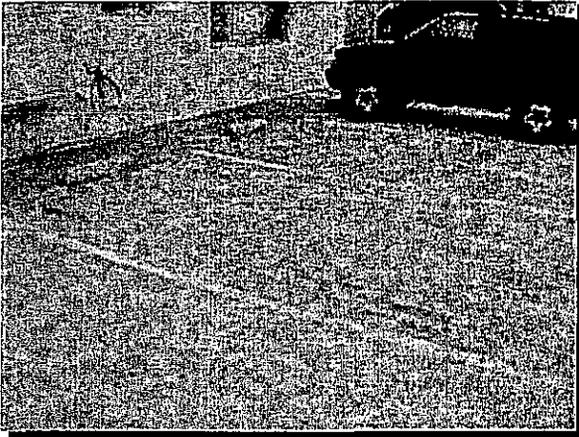
3.3 Picture 1

- (1) There are common cracks and some settling in the driveway. The driveway is otherwise in adequate condition. Sealing the cracks and resurfacing will extend the useful life of the drives

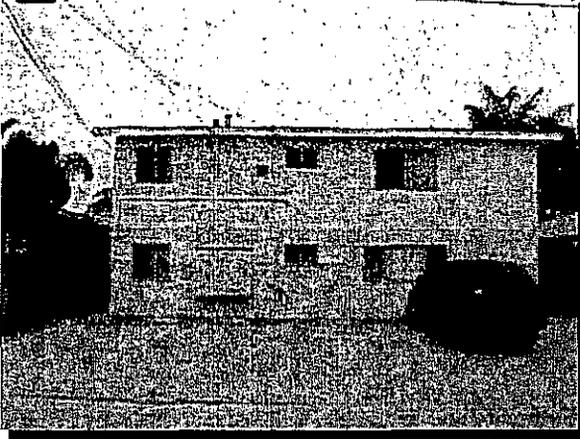
3.8 Picture 1

- (1) Sections of the stucco at the front, rear and sides of the structure are damaged. A qualified technician could make repairs or modifications as necessary.

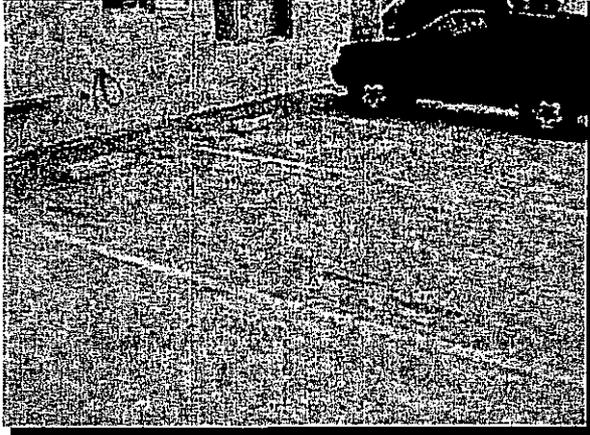
3.3 Picture 1

- (1) There are common cracks and some settling in the driveway. The driveway is otherwise in adequate condition. Sealing the cracks and resurfacing will extend the useful life of the drives

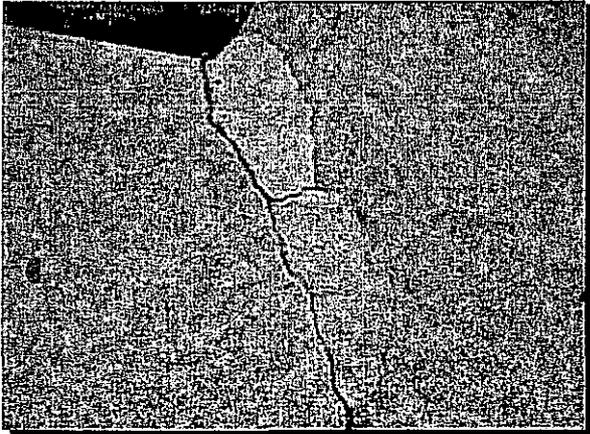
3.3 Picture 2

- (2) There are several cracks and vertical displacement greater than 3/4 of an inch in the walkways. This is a potential trip concern for persons using the walkways. As a safety upgrade, grinding down the affected areas is recommended.

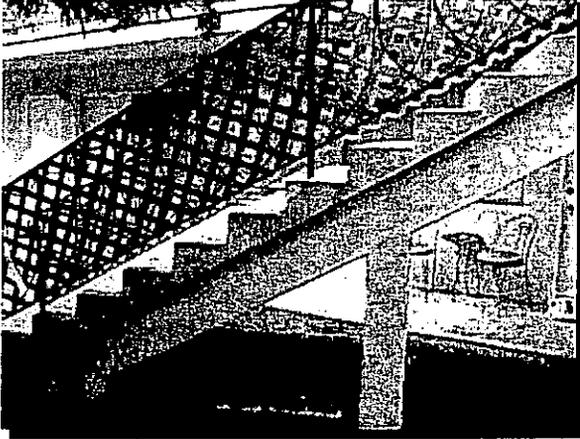
3.4 Picture 1

- (1) The exterior stair handrails at the right side (facing front) are damaged a baluster is corroded and and broken free from the concrete step. All handrails or guardrails need proper attachment or securing to provide adequate support and safety. Have a qualified technician repair or replace the railing.

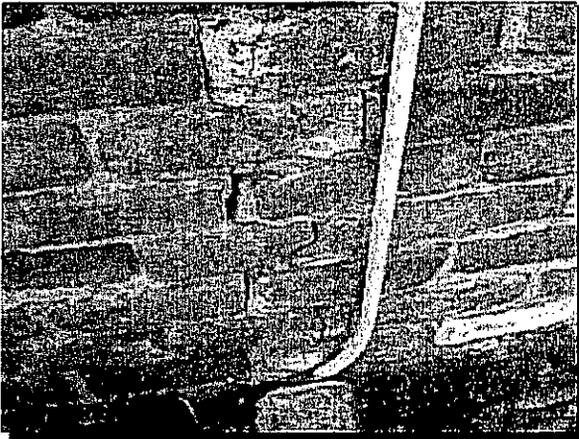
3.6 Picture 1

- Settlement cracking of south brick and mortar pony wall. Stabilize and repair crack.

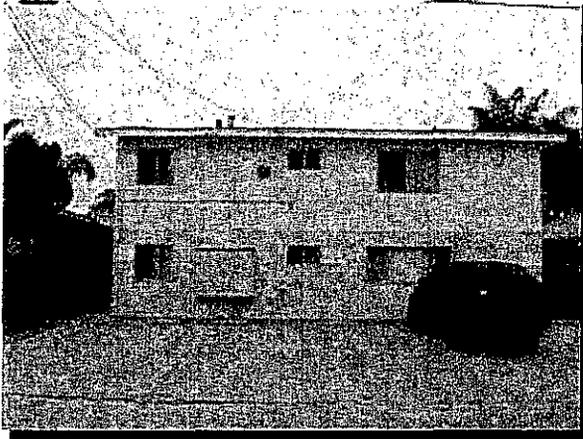
3.8 Picture 1

- (1) Sections of the stucco at the front, rear and sides of the structure are damaged. A qualified technician could make repairs or modifications as necessary.

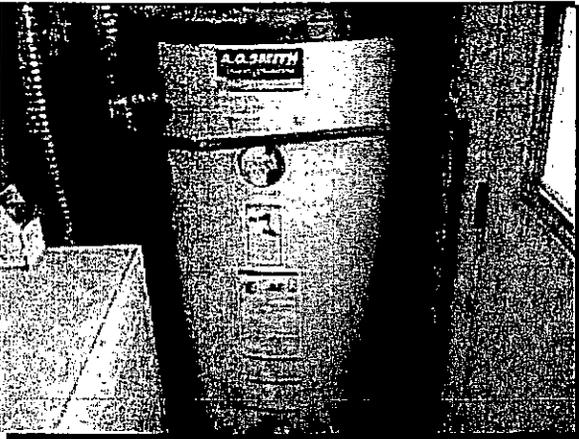
5.6 Picture 1

Water heating is provided by a common 75 gallon gas water heater. The water heater is fifteen years old. Normal water heater life expectancy is 8 to 12 years. The water heater will need to be replaced to obtain a useful life in excess of five years

1	Replace water heater	\$1500			
2					
3					
4					
5					
6
