FAULTING AND BLUFF GEOLOGIC EVALUATION
PROPOSED LUSARDI RESIDENCE
8466 EL PASEO GRANDE
LA JOLLA, CALIFORNIA

CTE JOB NO. 10-8264G

FEBRUARY 12, 2007

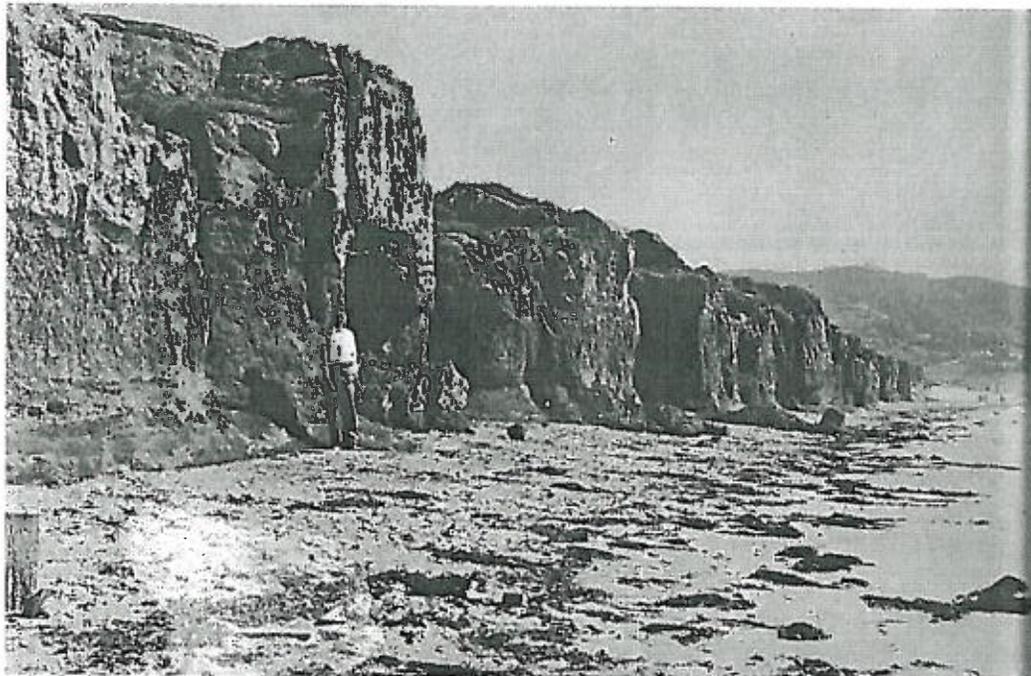
Photo #2: View of low-lying alluvial cliffs 1936 (approximate location at 8516 El Paseo Grande Cliff erosion rate at that time estimated at one foot per year (photo from U.S. Grant View Kuhu, 1984)

According to Kuhn (1984), climatic conditions prior to 1978 were milder and the bluff faces became rounded and more vegetated than the steep faces show in the 1936 photograph. This implies the gradient of the bluff faces decreased during this time of mild climatic conditions.

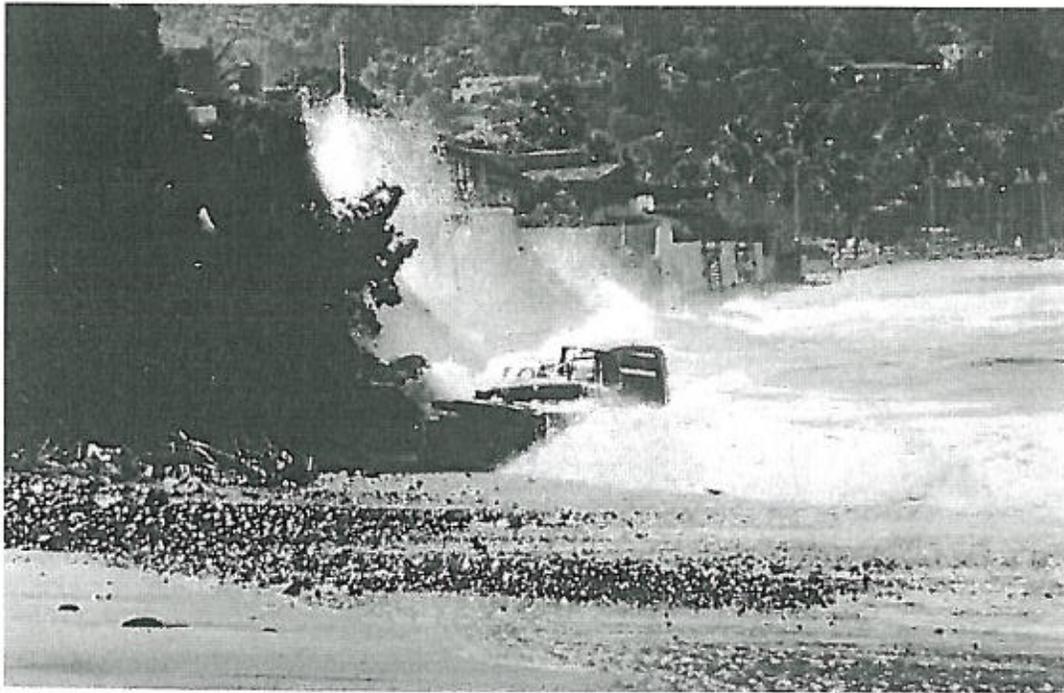
Photo #3: View at same location as Photo #2 during heavy storms of 1978 (Kuhn, 1984)

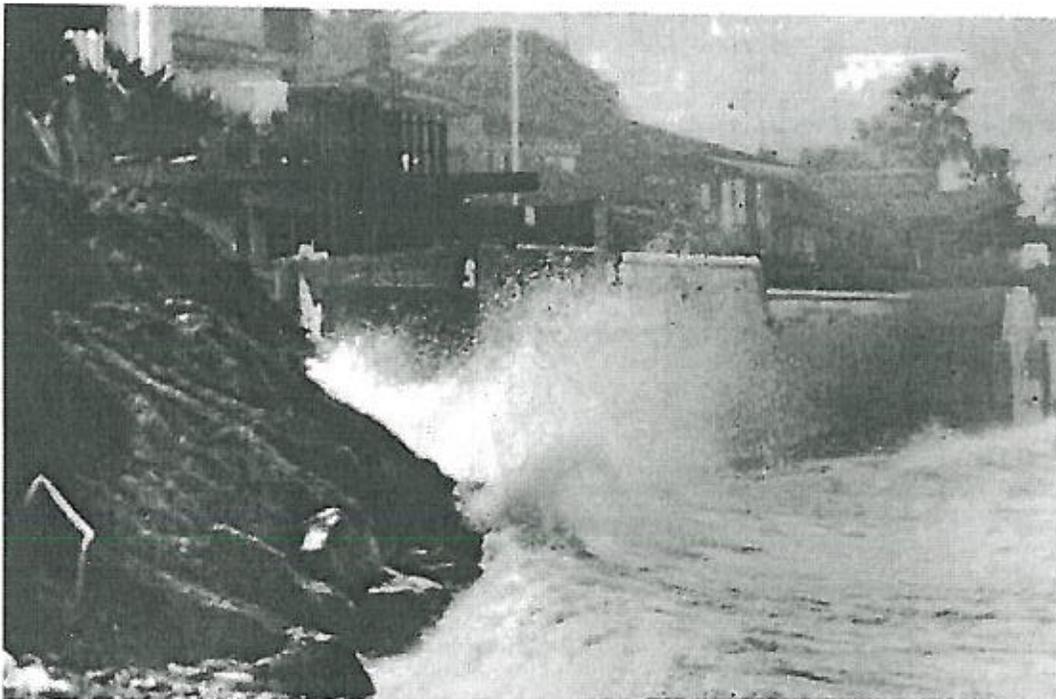
Photo #4: Same Location as Photo #3 1978 (Kuhn, 1984)

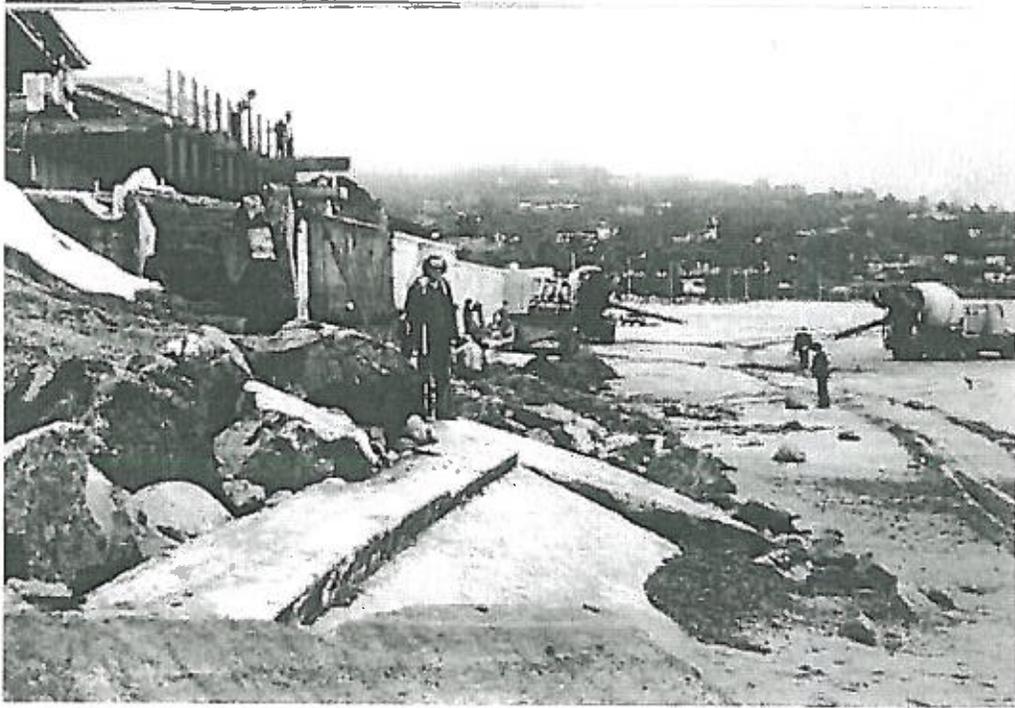
Photo #5: Same location as Photo #2-#5, showing partial collapse of seawall in 1978 (Kuhn, 1984)

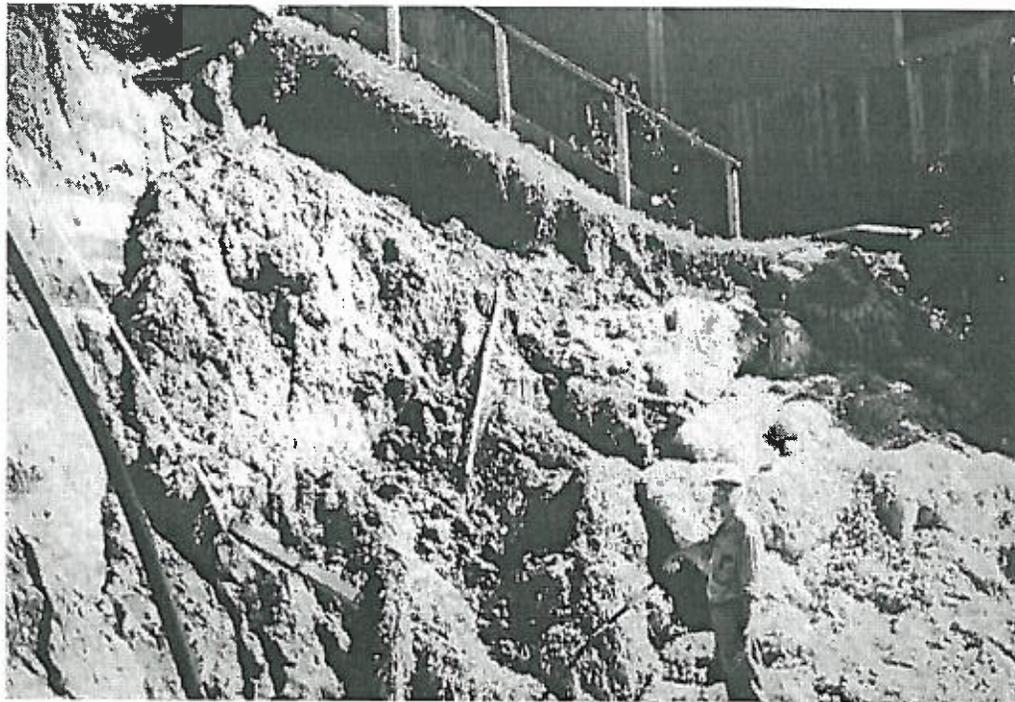
Photo #6: Up to 15 feet local retreat in general area as Photo #5 (Kuhn, 1984)
