REQUEST FOR COUNCIL ACTION CITY OF SAN DIEGO				CERTIFICATE NUMBER (FOR COMPTROLLER'S USE ONLY)	
TO: CITY COUNCIL		FROM (ORIGINATING DEPARTMENT): Transportation&Storm Water Dept		DATE: 9/17/2015	
SUBJECT: Winter Storm Preparation, Master Maintenance Program Annual Report and Channel Prioritization					
PRIMARY CONTACT (NAME, PHONE): Gene Matter,(619) 527-7506; MS 44			SECONDARY CONTACT (NAME, PHONE): Drew Kleis, (858) 541-4320; MS 1900		
COMPLETE FOR ACCOUNTING PURPOSES					
FUND					
FUNCTIONAL AREA					
COST CENTER					
GENERAL LEDGER ACCT					
WBS OR INTERNAL ORDER					
CAPITAL PROJECT No.					
AMOUNT	0.00	0.00	0.00	0.00	0.00
FUND					
FUNCTIONAL AREA					
COST CENTER					
GENERAL LEDGER ACCT					
WBS OR INTERNAL ORDER					
CAPITAL PROJECT No.					
AMOUNT	0.00	0.00	0.00	0.00	0.00
COST SUMMARY (IF APPLICABLE): This is an informational item only					
ROUTING AND APPROVALS					
CONTRIBUTORS/REVIEWERS:		APPROVING AUTHORITY	APPROVAL SIGNATURE	DATE SIGNED

COUNCIL ACTION
EXECUTIVE SUMMARY SHEET
CITY OF SAN DIEGO

SUBJECT: Winter Storm Preparation, Master Maintenance Program Annual Report and Channel Prioritization

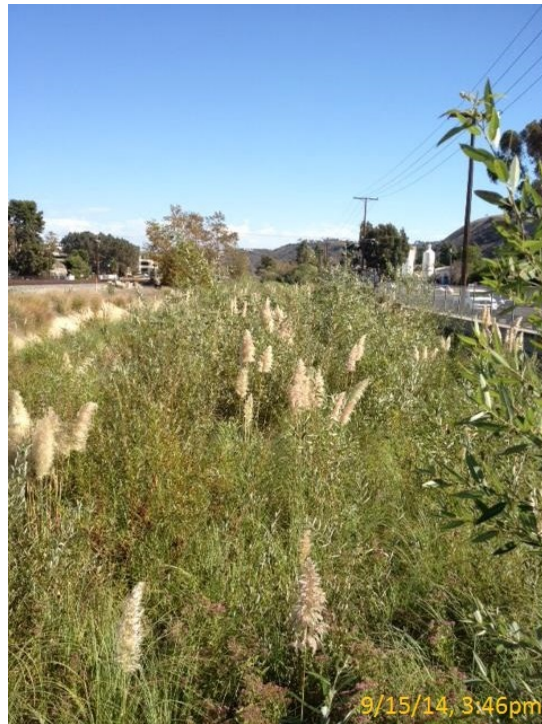
Photo 1. Sorrento Creek Reach 3 Pre-Maintenance 9/15/14

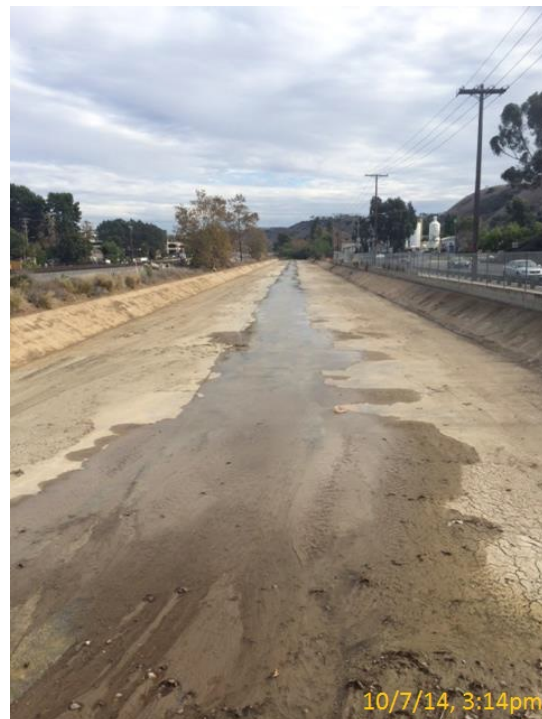
Photo 2. Sorrento Creek Reach 3 Post-Maintenance 10/7/14

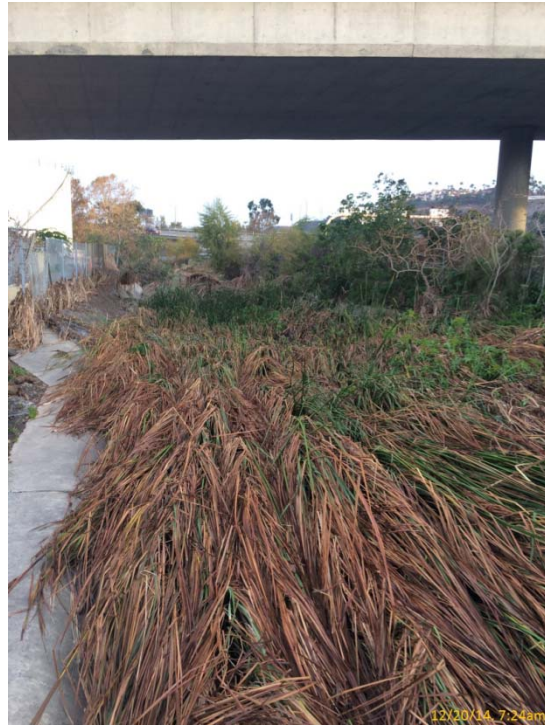
Photo 3. Murphy Canyon Creek Channel Pre-Maintenance 12/20/14

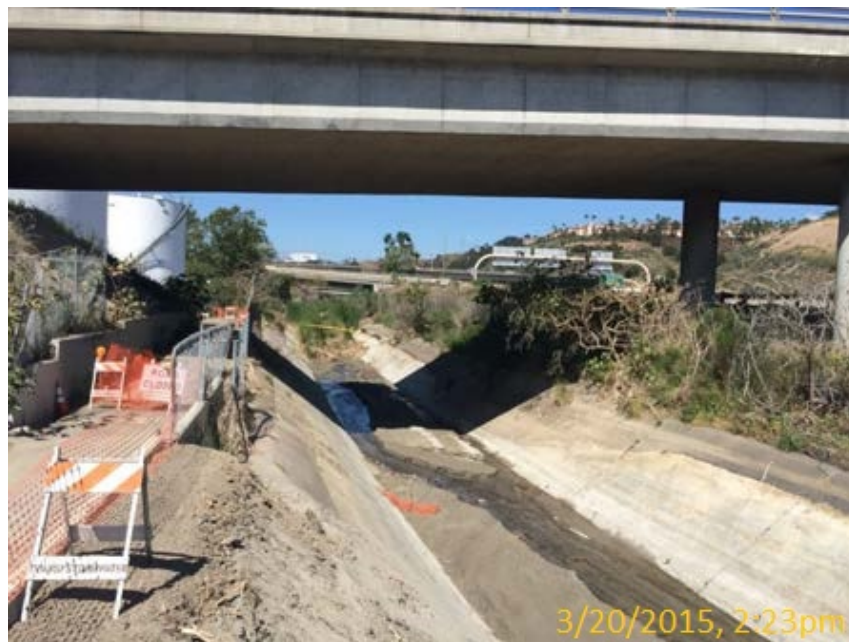
Photo 4. Murphy Canyon Creek Channel Post-Maintenance 3/20/15

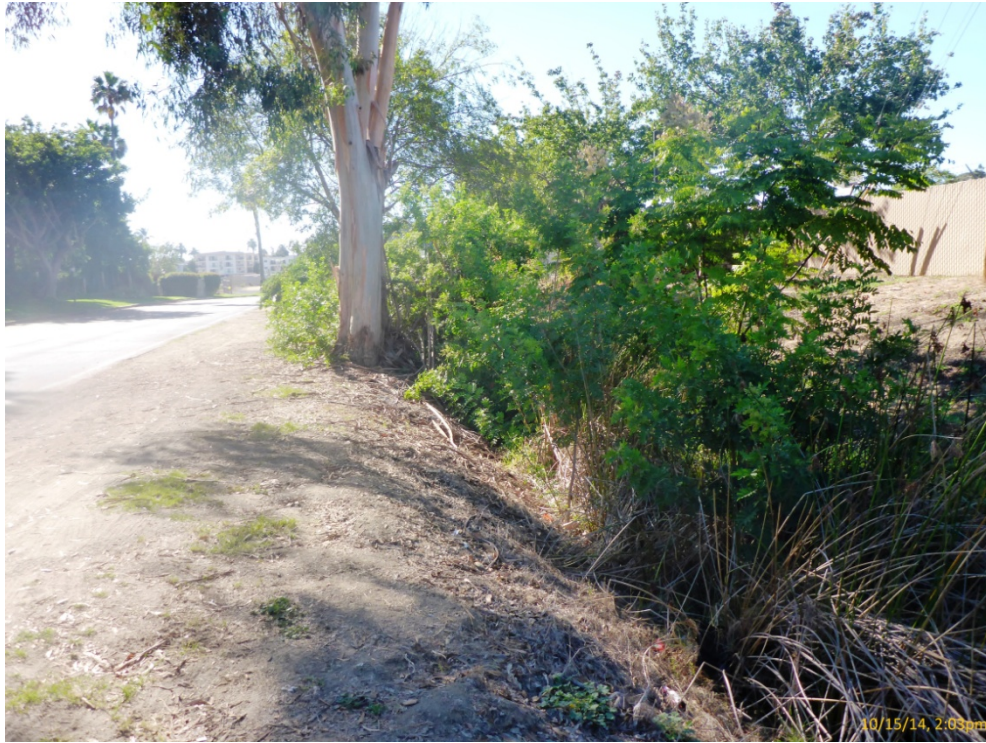
Photo 5. Mission Bay High School and Pacific Beach/Olney Street Channels Pre-Maintenance 10/15/14

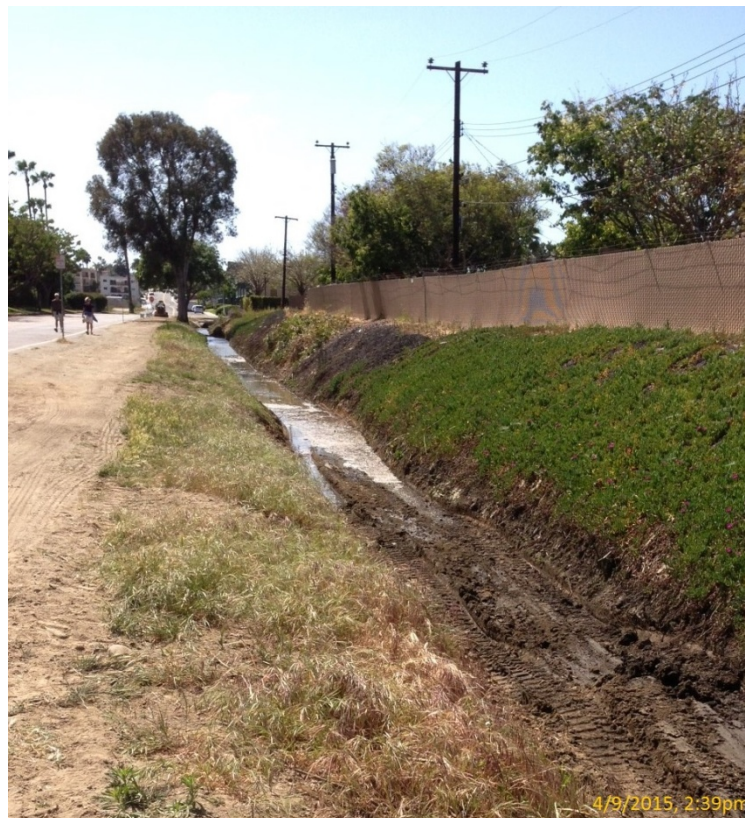
Photo 6. Mission Bay High School and Pacific Beach/Olney Street Channels Mid-Maintenance 4/9/15

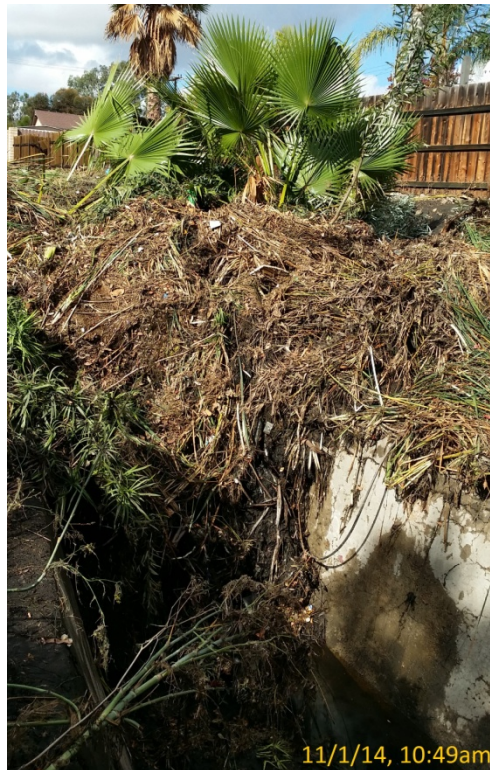
Photo 7: San Carlos Creek Channel Emergency Pre-Maintenance 11/1/14

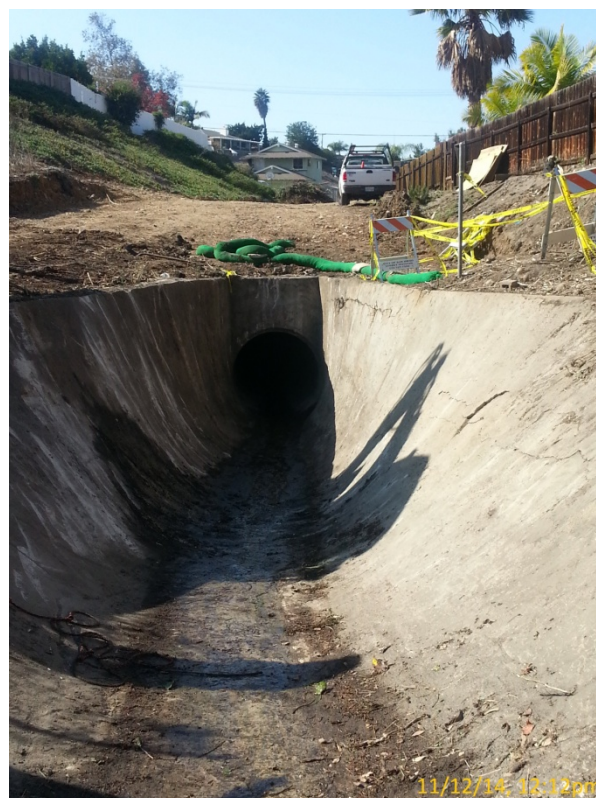
Photo 8: San Carlos Creek Channel Emergency Post-Maintenance 11/12/14

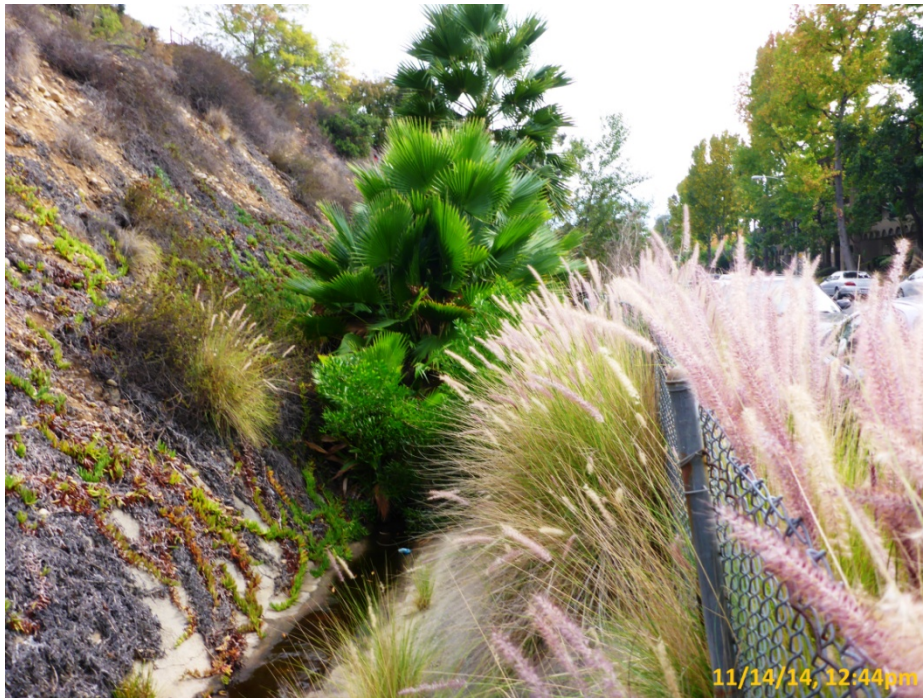
Photo 9: Reservoir Drive Channel Emergency Pre-Maintenance 11/14/14

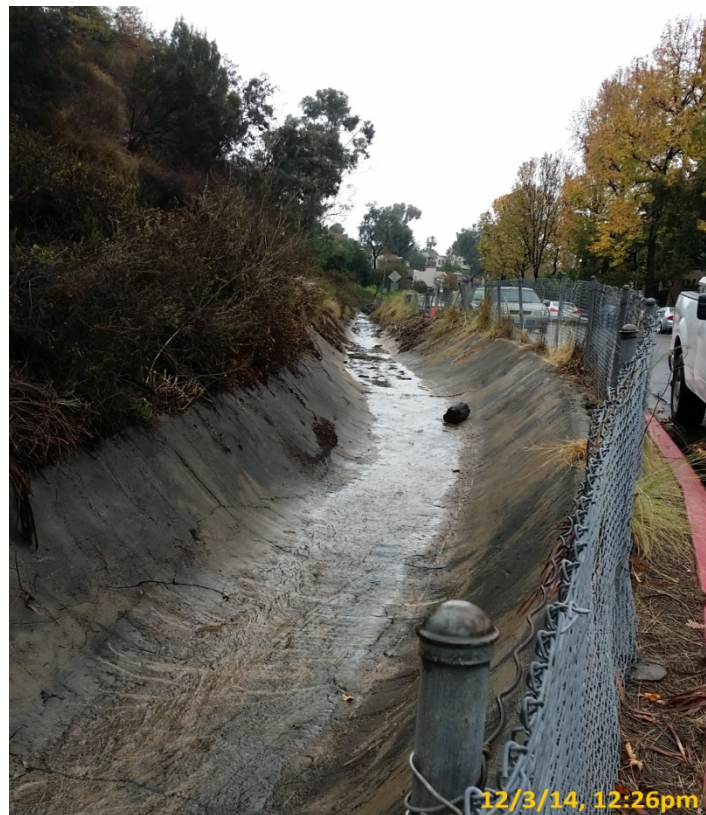
Photo 10: Reservoir Drive Channel Emergency Post-Maintenance 12/3/14

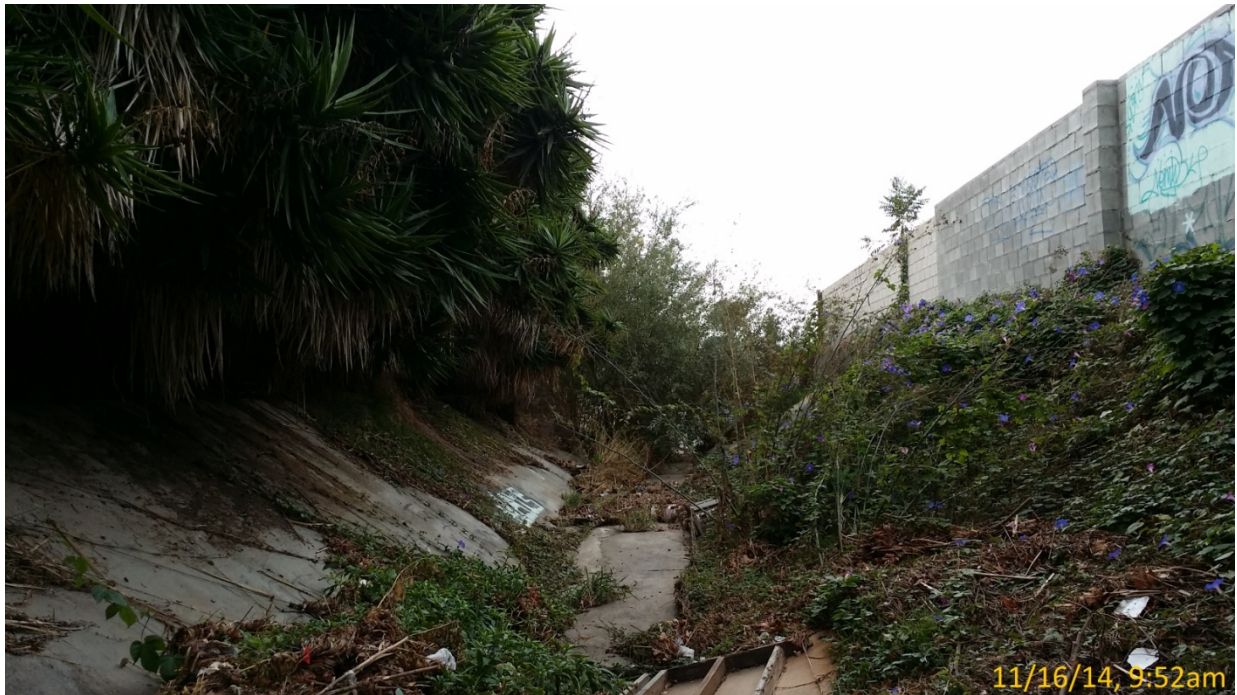
Photo 11: Smythe Channel Emergency Pre-Maintenance 11/16/14

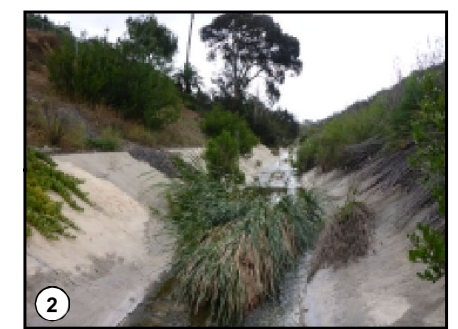
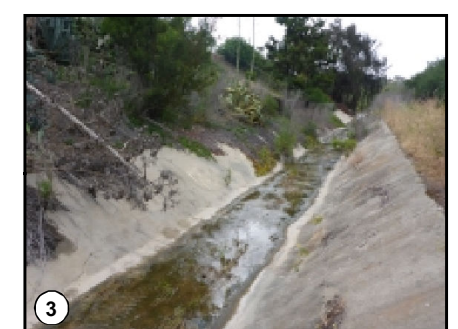
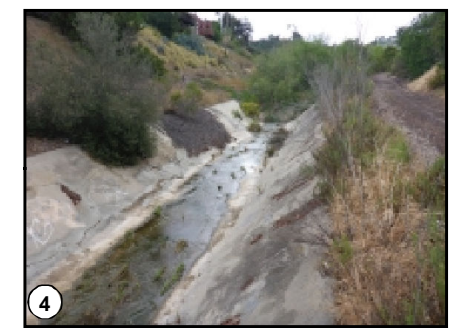
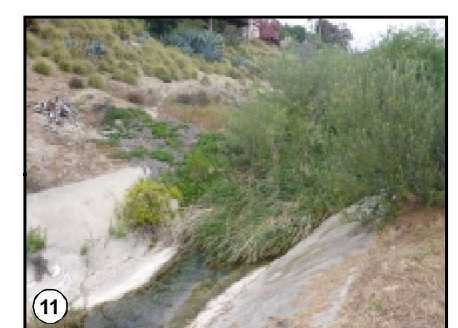
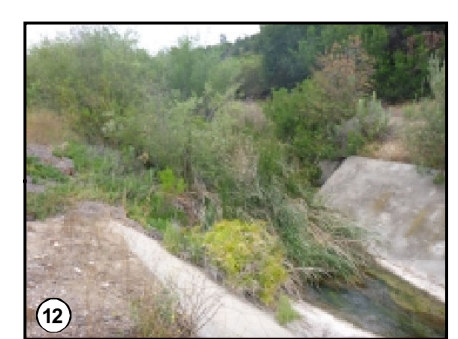
y fl dWps ars α DWs α p8
Holes and cracks in gunite channel

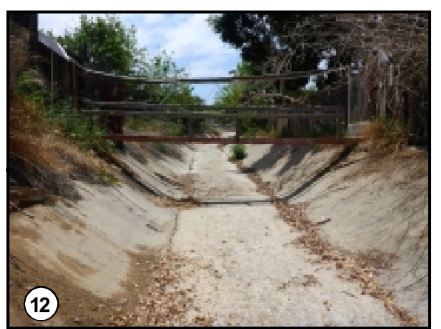
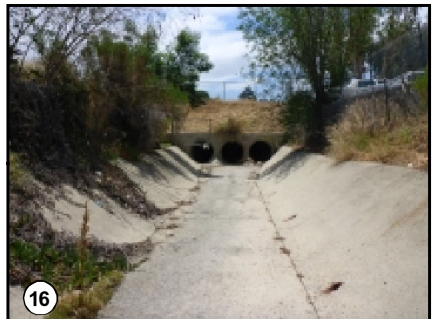
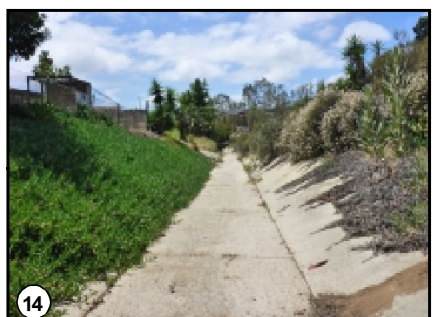
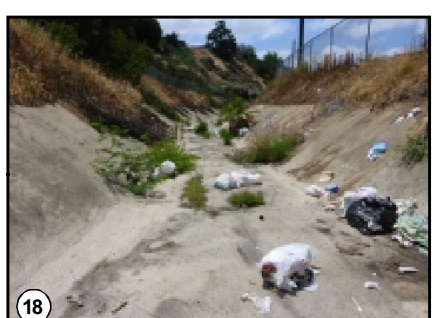
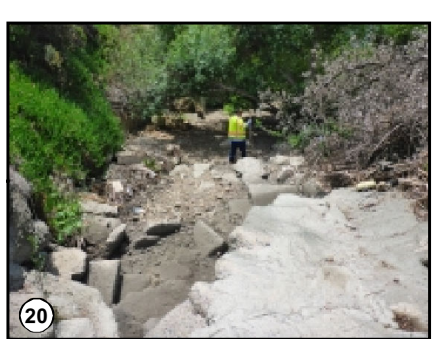
B g_ nndl: Auaur B rddi (Rdbtton 2 L L NL _ p # 58 oe3)

lpgbutxdwxf Hblxtf uB
Broken concrete in channel bottom,
Broken fence
Vf Fybrxvbr p E bvf B
May 4, 2015

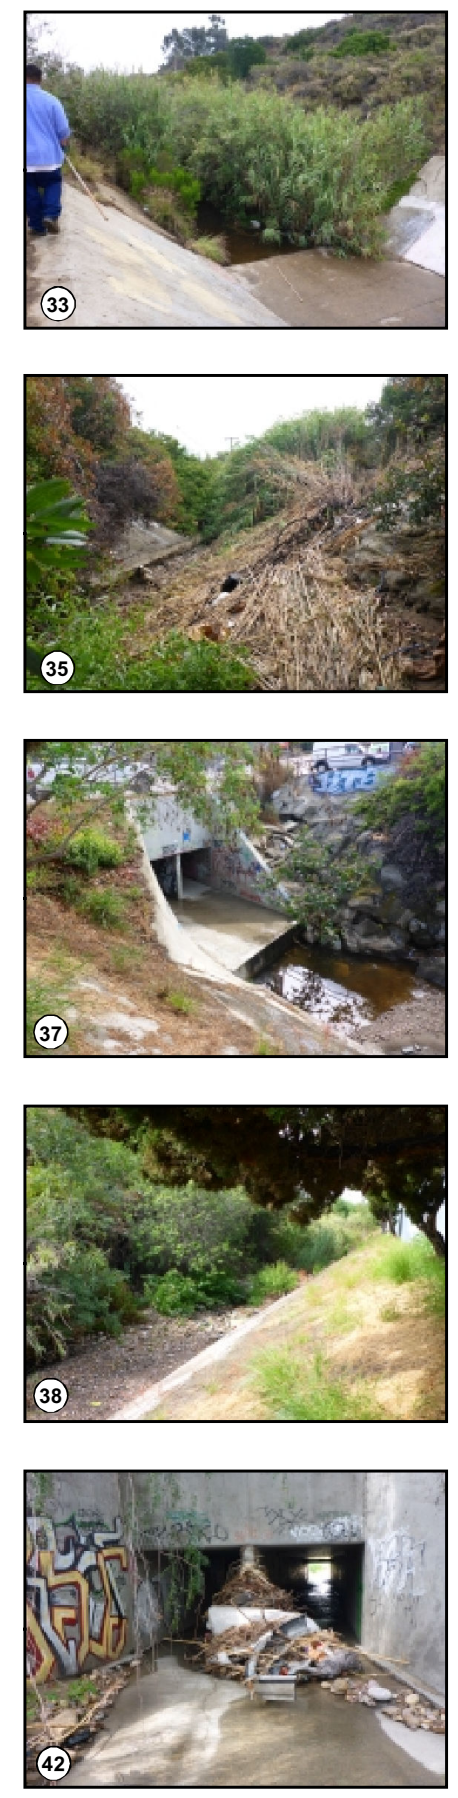
Af Wmci8: t _t pncch (Qc asgm3 I I MI Wo # 50 nd3)

- : rrcrri cms Pct is**
- z Af Wmci Mnggy Wsgm Qnc8
86.5 out of 100
 - z Dnnb E Wp Gnc8
70.0 out of 75
 - z S WscpNt Wgx Qnc8
4 out of 10
 - z Anl I t mxx frnt s Qnc8
10 out of 10
 - z : crf csgn Qnc8
2.5 out of 5
 - z AWoWagx Mngpsn I WgrscnWtrac8
5-year storm event
 - z AWoWagx : dcpl WgrscnWtrac
(: r_ t gs AWoWagx) 8
100-year storm event
 - z Ainegre Mnsn W8HIGH
 - z : oopvlg Wsc Rcecs Wsgm
AnucpWec8HIGH
 - z Q pnt rbgre : p W8Commercial
 - z frp W sp ast p DWt pcr 8
None
 - z Qgc CuWt Wsgm B Wsc8
May 4, 2015
 - z L nscr/Anl I cnc8
Evidence of scour at outfall of culvert
under Fairmount Avenue (photo 37)
and along right toe of slope (looking
downstream) near middle of reach
(photo 35)

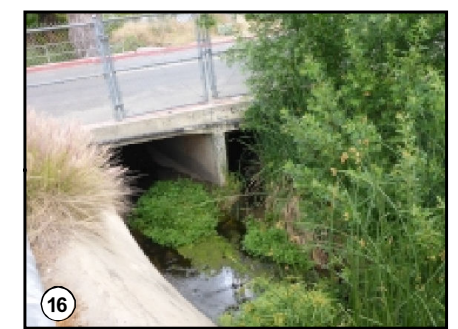
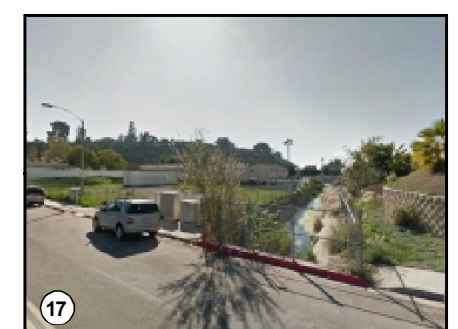
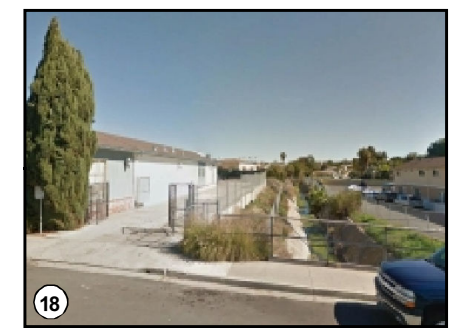
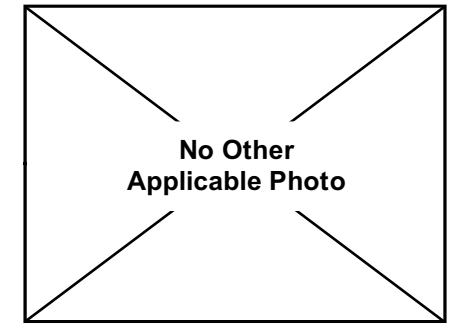
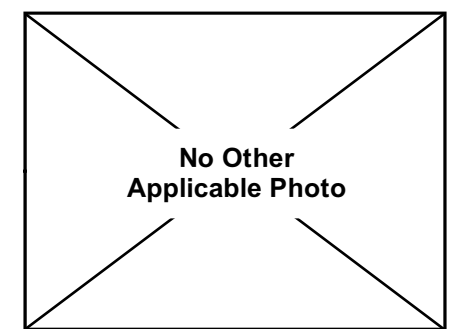
Af Wmci8Af niW Apch | | MI Wb # 51 - PcWaf 1 Af Wmci | WgrscnWtrac MnggyWsgmG | | Wp G ccs

- z Af Wmci MnggyWsgmGpc8**
72.8 out of 100
- z Dnnb E WyWb Gpc8**
56.3 out of 75
- z S WscpNt Wgx Gpc8**
4 out of 10
- z Anl I t mxx frnt s Gpc8**
10 out of 10
- z : crf csg Gpc8**
2.5 out of 5
- z AWoWagx Mngpsn I WgrscnWtrac8**
100-year storm event
- z AWoWagx : dcpl WgrscnWtrac**
(: r_ t gs AWoWagx) 8
100-year storm event
- z Ainegre MscnsgW8HIGH**
- z : oopvlg Wsc RcecsWsgm**
AnucpWec8MEDIUM
- z Q pnt nbgre : pcW8Commercial**
- z frpWst ast pc DWt pcr8**
None
- z Gpc CuWt WsgmB Wsc8**
May 6, 2015
- z L nscr/Anl I cnsr8**
Based on site photos taken by the City of San Diego, heavier vegetation exists for a small segment of the channel immediately downstream of Roland Boulevard. A high risk of vegetation flowing downstream and clogging the culvert exists.

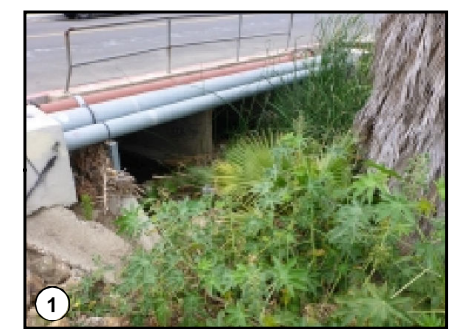
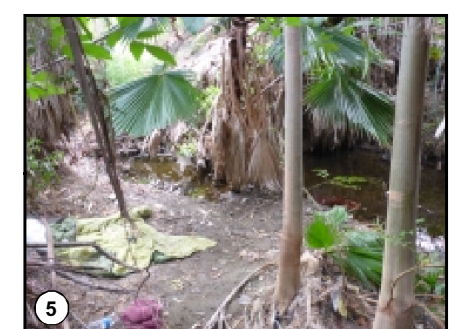
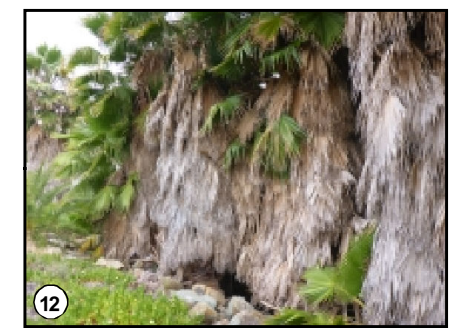
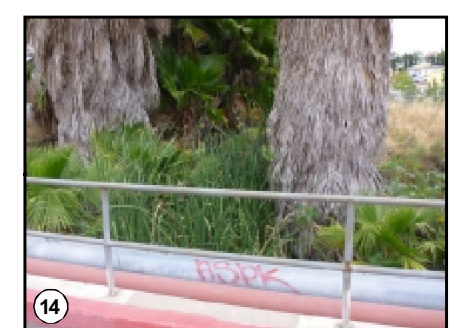
Af Wmci8Af niW Apch | I MI Wb # 51 - PcWaf 2

- z Af Wmci MnggyWsgm Qnrc8
87.3 out of 100
- z Dnnb E WYwb Qnrc8
68.8 out of 75
- z S WscpNt Wgx Qnrc8
6 out of 10
- z Anl I t mnx frnt s Qnrc8
10 out of 10
- z : crsf csgr Qnrc8
2.5 out of 5
- z A WbWagx Mngpsn I WgrscnWtrac8
Less than 2-year storm event
- z A WbWagx : dcpl WgrscnWtrac
(: r_ t gs A WbWagx) 8
50-year storm event
- z Ainegre MnsrnyW8HIGH
- z : oopvlg Wsc RcecsWsgm
AnucpWec8HIGH
- z Q pnt rbgre : pcWBResidential
- z FrqW sp ast pc DWt pcr 8
None
- z Qgc CuWt WsgmB Wsc8
May 6, 2015
- z L nscr/Anl I cnsr 8
Palm trees exist along entire reach.

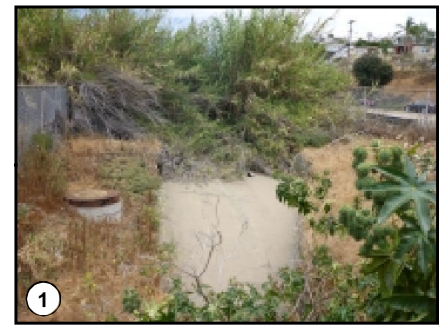
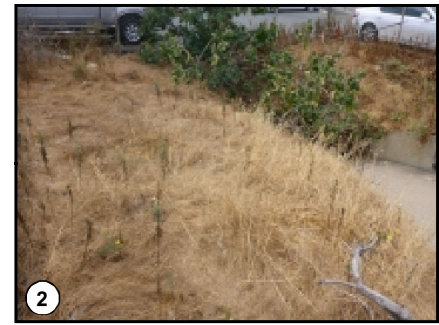
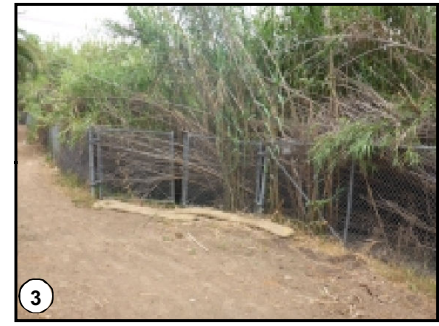
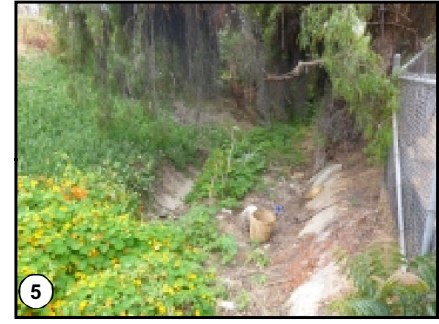
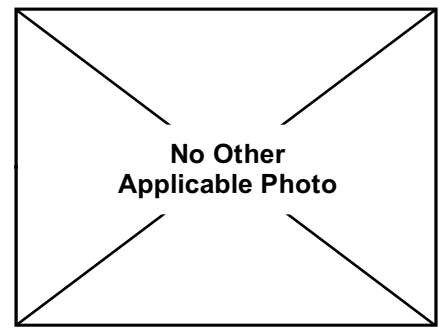
I I MI Wh # 73

- Af W I chQ d cv**: 83.3 out of 100
- Dimb E Wk Wb**: 71.3 out of 75
- S WcoNs Wrgv**: 4 out of 10
- Ani i sl gv fl nsr**: 8 out of 10
- cpf crp**: 0 out of 5
- AWhWagv Mgrorml Wj rcl W ac8**: Less than 2-year storm event
- AWhWagv : dcol Wj rcl W ac** (p_s gr AWhWagv) 8: 100-year storm event
- Almeeg e Mtrcl rW8HIGH**
- nnoug Wc RcecrWgrl Ant cdWec8HIGH**
- Qs ars l bge : acWBResidential**
- fl dWras ars ac DWs acp8**: None
- Qgc G Ws Wgrl B Wc8**: May 5, 2015
- L mcp/Ani i cl rp8**: Based on site photos taken by the City of San Diego, heavy vegetation exists in the downstream end of the channel. A high risk of vegetation clogging the downstream culvert exists.

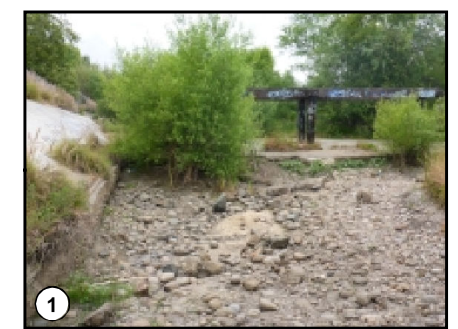
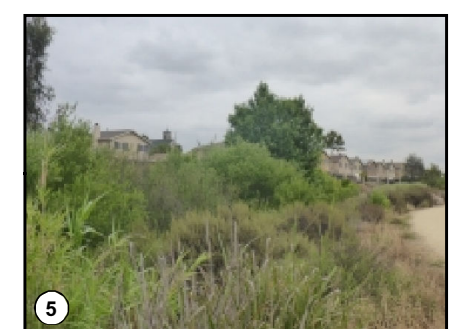
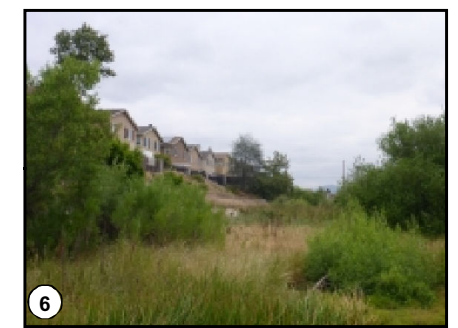
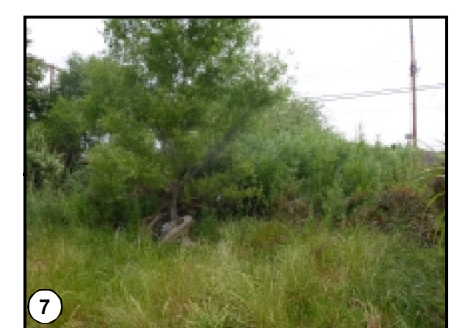
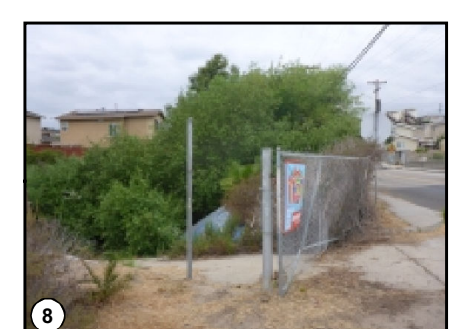
- B g_nndl Nrlrhlz_tlon Rbord: 75.0 out of 100
 - Elooc F_z_rc Rbord: 65.0 out of 75
 - V_tdr P_u_lly Rbord: 2 out of 10
 - B ommunity Htput Rbord: 8 out of 10
 - Adstgdltbs Rbord: 0 out of 5
- B_p_bly Nrlr to L _mntdn_nbd: 5-year storm event
- B_p_bly Aedr L _mntdn_nbd (As-ault B_p_bly): 25-year storm event
- B lof f mf Notdnth_l: HIGH
- Approxm_td S df dt_tlon B ovdr_f d: HIGH
- Rurrounchmf Ard_: Residential
- Hre_struburd E_hurds: None
- Rhtd Dv_lu_tlon C_td: May 5, 2015
- Motds/B ommdnts: Moderate erosion in west end of channel near the foot bridge

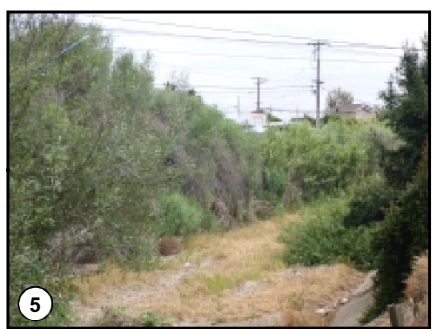
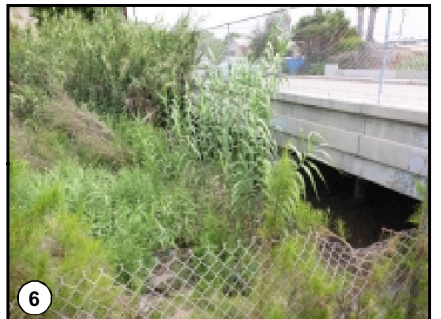
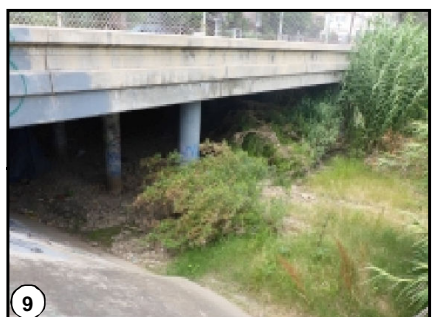
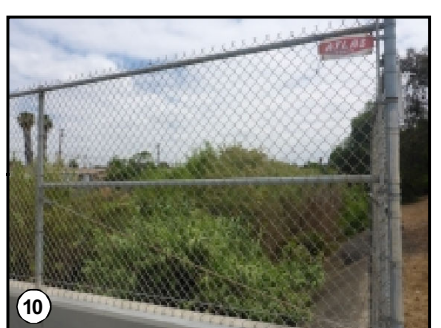
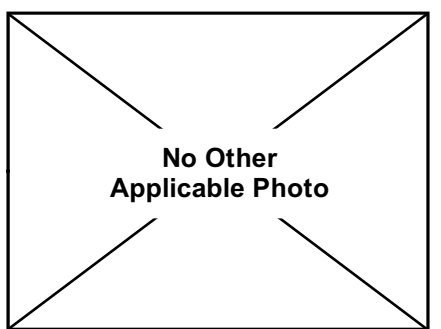
- **B g _ n n d l N o r t h _ t i o n R b o r d:**
74.8 out of 100
 - **E l o o c F _ z _ r c R b o r d:**
63.8 out of 75
 - **V _ t d r P u _ l t y R b o r d:**
3 out of 10

- **R t d D v _ l u _ t i o n C _ t d:** May 5, 2015
- **M o t d s / B o m m d n t s:**
A high risk of vegetation flowing downstream and clogging the culvert exists. It was noted on the O&M Channel Maintenance Inspection Form completed for the channel by the City of San Diego that there is broken gunite near the foot bridge to the park.

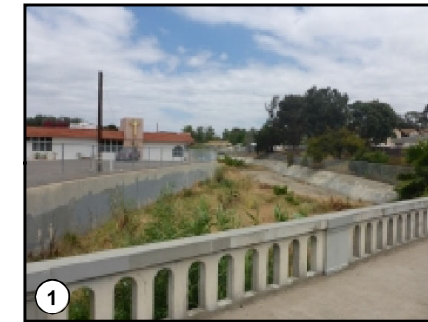
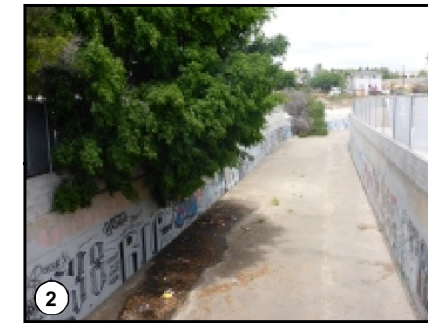
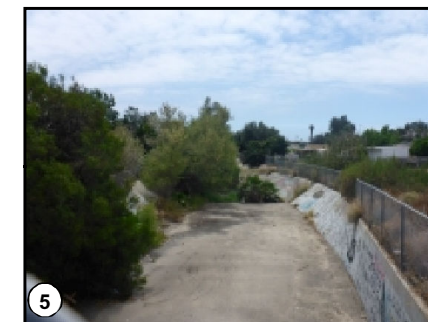
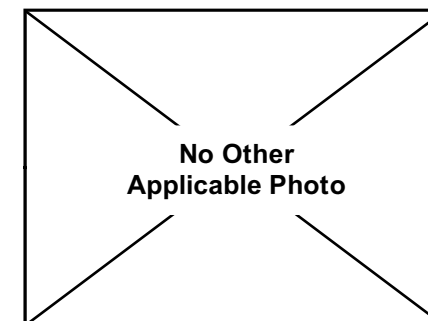
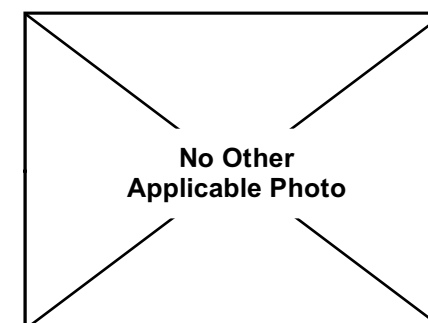
- B g_ nndl Ntortlz_ tton Rbord: 80.0 out of 100
 - Elooc F_ z_ rc Rbord: 65.0 out of 75
 - V_ tdr P_ u_ lthy Rbord: 6 out of 10
 - B ommunity Htput Rbord: 9 out of 10
 - Adstgdthb Rbord: 0 out of 5
- B_ p_ bly Ntort to L_ mtdn_ nbd: 10-year storm event
- B_ p_ bly Aedr L_ mtdn_ nbd (As-ault B_ p_ bly): 100-year storm event
- Blof f mf Notdnt h_ l: HIGH
- Approxm_ td S df dt_ tton B ovdr_ f d: HIGH
- Rurrounchmf Ard_ : Residential
- Ht_ struburd E_ Hurds: None
- Rhtd Dv_ lu_ tton C_ td: May 5, 2015
- Motds/B ommdnts: Debris accumulation on pipe near Alpha Project

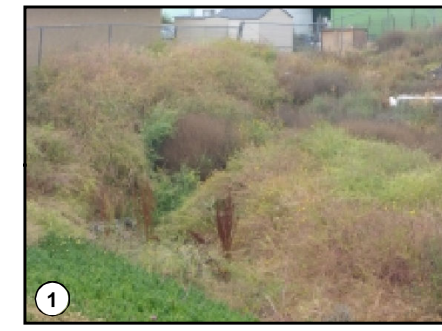
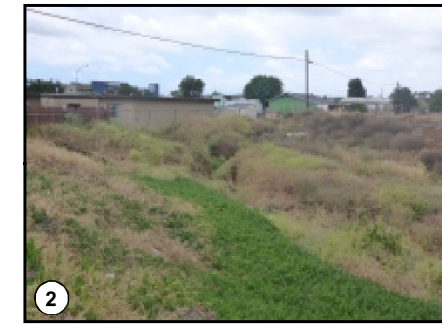
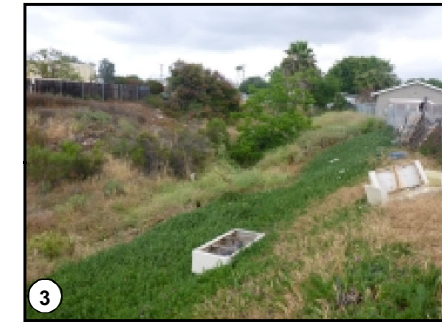
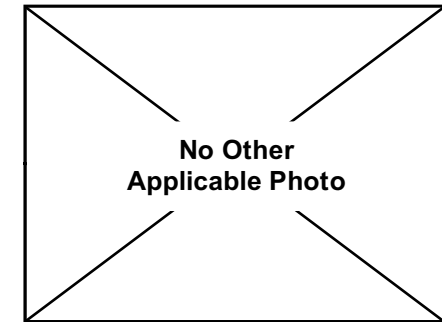
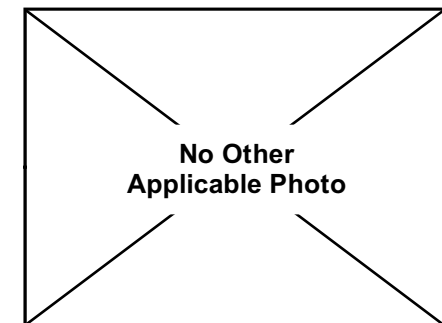
- z B_g_mmdi Ngnsnly_snmRbnpd: 51.9 out of 100
- z Einnc F_y_pc Rbnpd: 46.9 out of 75
- z V_sdpP t_lisx Rbnpd: 4 out of 10
- z Bnl l t mlsx Hrot s Rbnpd: 1 out of 10
- z Adrsgdslbr Rbnpd: 0 out of 5
- z B_o_blsx Ngnsn L_lmsdm_rbd: 100-year storm event
- z B_o_blsx Aesdpl_lmsdm_rbd)Ar/at lis B_o_blsx, : 100-year storm event
- z Binf f hmi Nnsdsh i: HIGH
- z Aoopvlt _sd S df ds_snm B nudp f d: MEDIUM
- z Rt ppt rrc hmi Apd_ : Residential
- z Htrp_rsp bst pd E_lit pd: None
- z Rhod Du_it_snmC_sd: May 9, 2015
- z MnsdrOB nl l dms: The culvert entrance at the downstream end of the channel is protected by a grate. This grate is partially clogged and recommended for maintenance to prevent the grate from fully clogging.

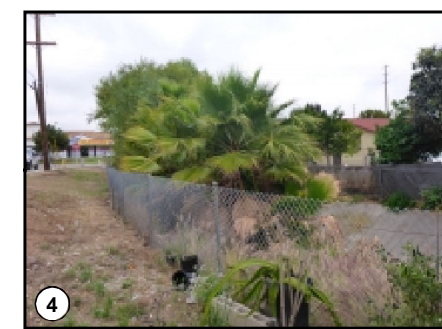
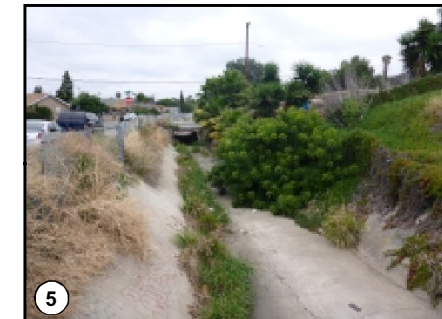
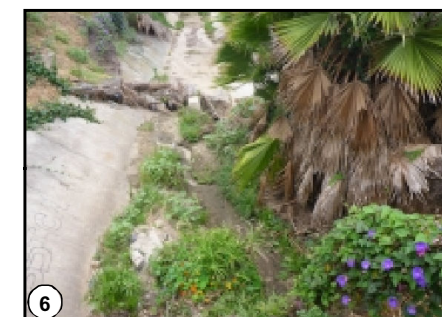
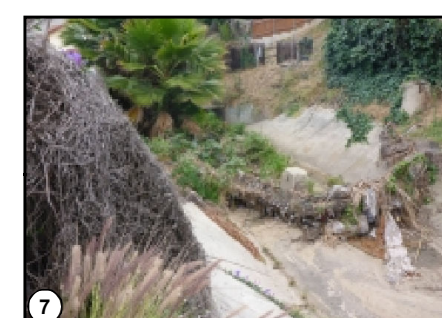
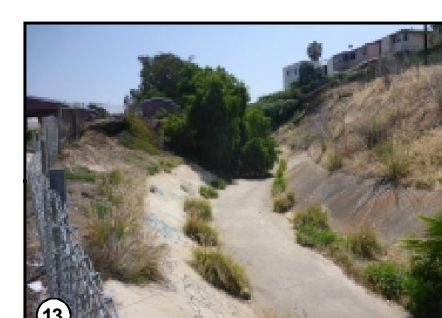
M mrm8

- : ppcpi cl r Pcps hlp
- z Af W I chMmrgyWgrl Qmrc8
82.0 out of 100
- z Dmrb E WyWb Qmrc8
70.0 out of 75
- z S WcoNs Wgrx Qmrc8
6 out of 10
- z Ani i sl gx fl nsr Qmrc8
6 out of 10
- z : cpf crgp Qmrc8
0 out of 5
- z AWhWagx Mmrgmrl Wgrcl W ac8
Less than 2-year storm event
- z AWhWagx : dcol Wgrcl W ac
(: p_s gr AWhWagx) 8
25- to 50-year storm event
- z Almeeg e Mmrci rW8HIGH
- z : nncvg Wc RcecrWgrl
Ant cdWec8HIGH
- z Gsarsl bge : acW8Residential
- z fl dWpars ac DWg acp8
None
- z Ggc G Ws Wgrl B Wc8
May 27, 2015
- z L mrcp/Ani i cl rp8
Vegetation has grown down from the top of the channel banks over the concrete side slopes. A high risk of vegetation flowing downstream and clogging the culvert exists.

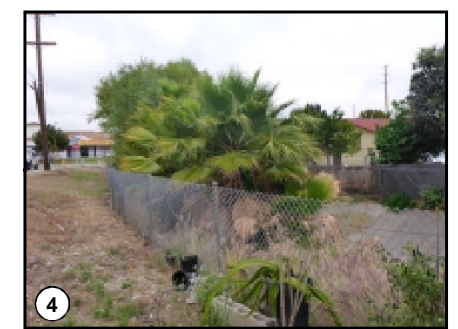
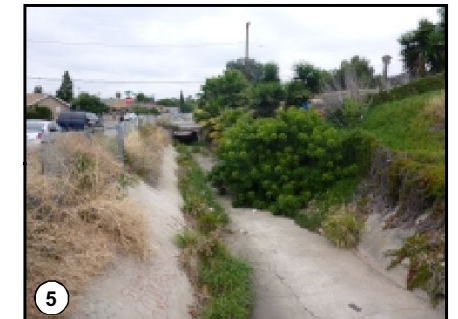
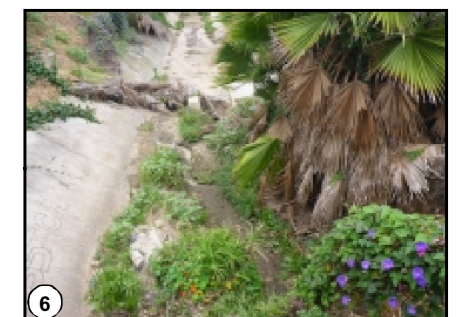
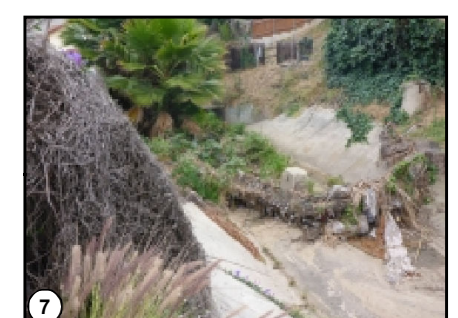
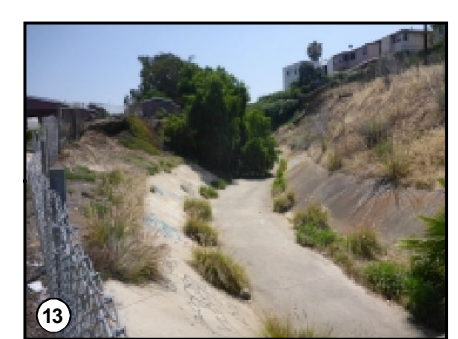
M mrm p8

- : ppcpi cl r Pcps hlp
- z Af W I chMmrgyWgrl Qamc8
82.0 out of 100
- z Dmmb E WyWb Qamc8
70.0 out of 75
- z S WcoNs Wgq Qamc8
6 out of 10
- z Ani i sl gx fl nsr Qamc8
6 out of 10
- z : cpf crgp Qamc8
0 out of 5
- z AWhWagx Mmrgmrl Wg rcl W ac8
Less than 2-year storm event
- z AWhWagx : dcol Wg rcl W ac
(: p_s gr AWhWagx) 8
25- to 50-year storm event
- z Almeeg e Mmrl rW8HIGH
- z : nnavg Wc RcecrWgrl
Ant cdWec8HIGH
- z G ars l bge : acWBResidential
- z fl dWras ars ac DWs ac p8
None
- z Ggc G Ws Wgrl B Wc8
May 27, 2015
- z L mrcp/Ani i cl rp8
Vegetation has grown down from the top of the channel banks over the concrete side slopes. A high risk of vegetation flowing downstream and clogging the culvert exists.

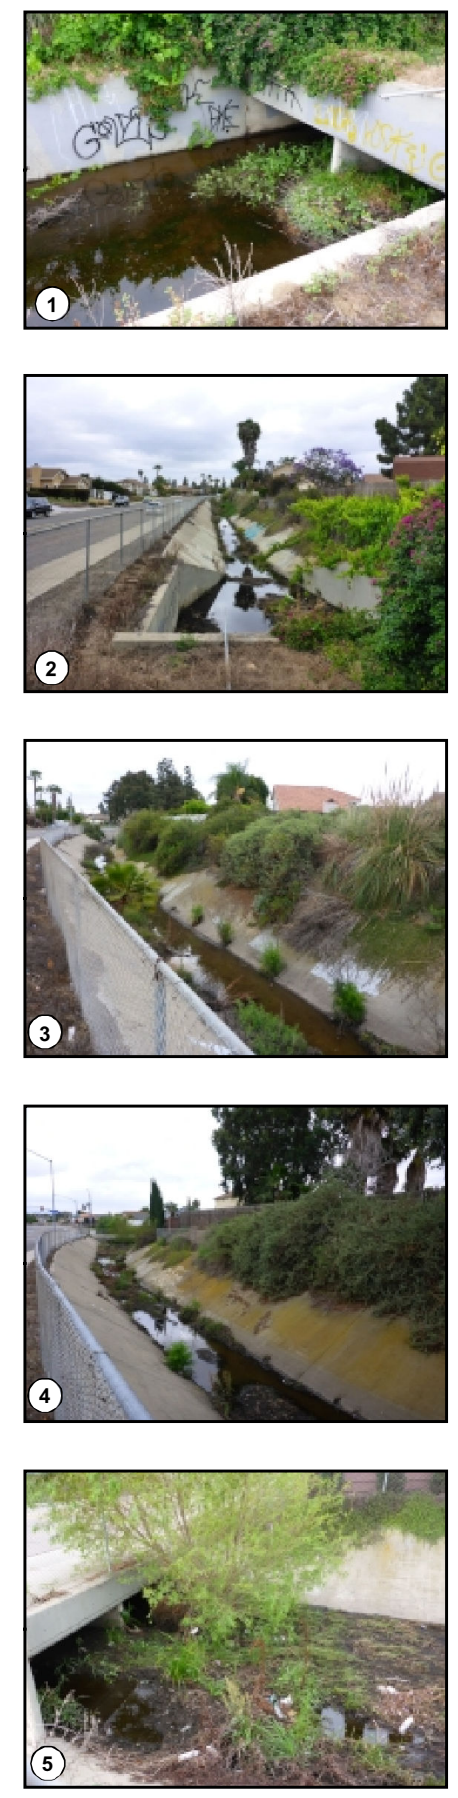
Photos:

- **B channel Nioritization Rcore:**
72.8 out of 100
 - Flood Fazard Rcore:
63.8 out of 75
 - Water P uality Rcore:
3 out of 10
 - B ommunity Hput Rcore:
6 out of 10
 - Aesthetics Rcore:
0 out of 5
- **B apacity Nior to L aintenance:**
Less than 2-year storm event
- **B apacity After L aintenance (As-built B apacity) :**
Less than 2-year storm event
- **B logging Notential:** MEDIUM
- **Approximate Vegetation B overage:** MEDIUM
- **Rurrounding Area:** Residential
- **Hnfrastructure Eailures:**
None
- **Rite Dvaluation Cate:**
May 16, 2015
- **Notes/B omments:**
There are sporadic patches of sediment and vegetation overhanging onto the side slopes throughout the channel. It is recommended that these be maintained in order to increase overall capacity of the channel.
